SCANTIC RIVER BASIN  
SCITICO, CONNECTICUT

SCITICO DAM  
CT 00529

PHASE I INSPECTION REPORT  
NATIONAL DAM INSPECTION PROGRAM

APRIL 1980

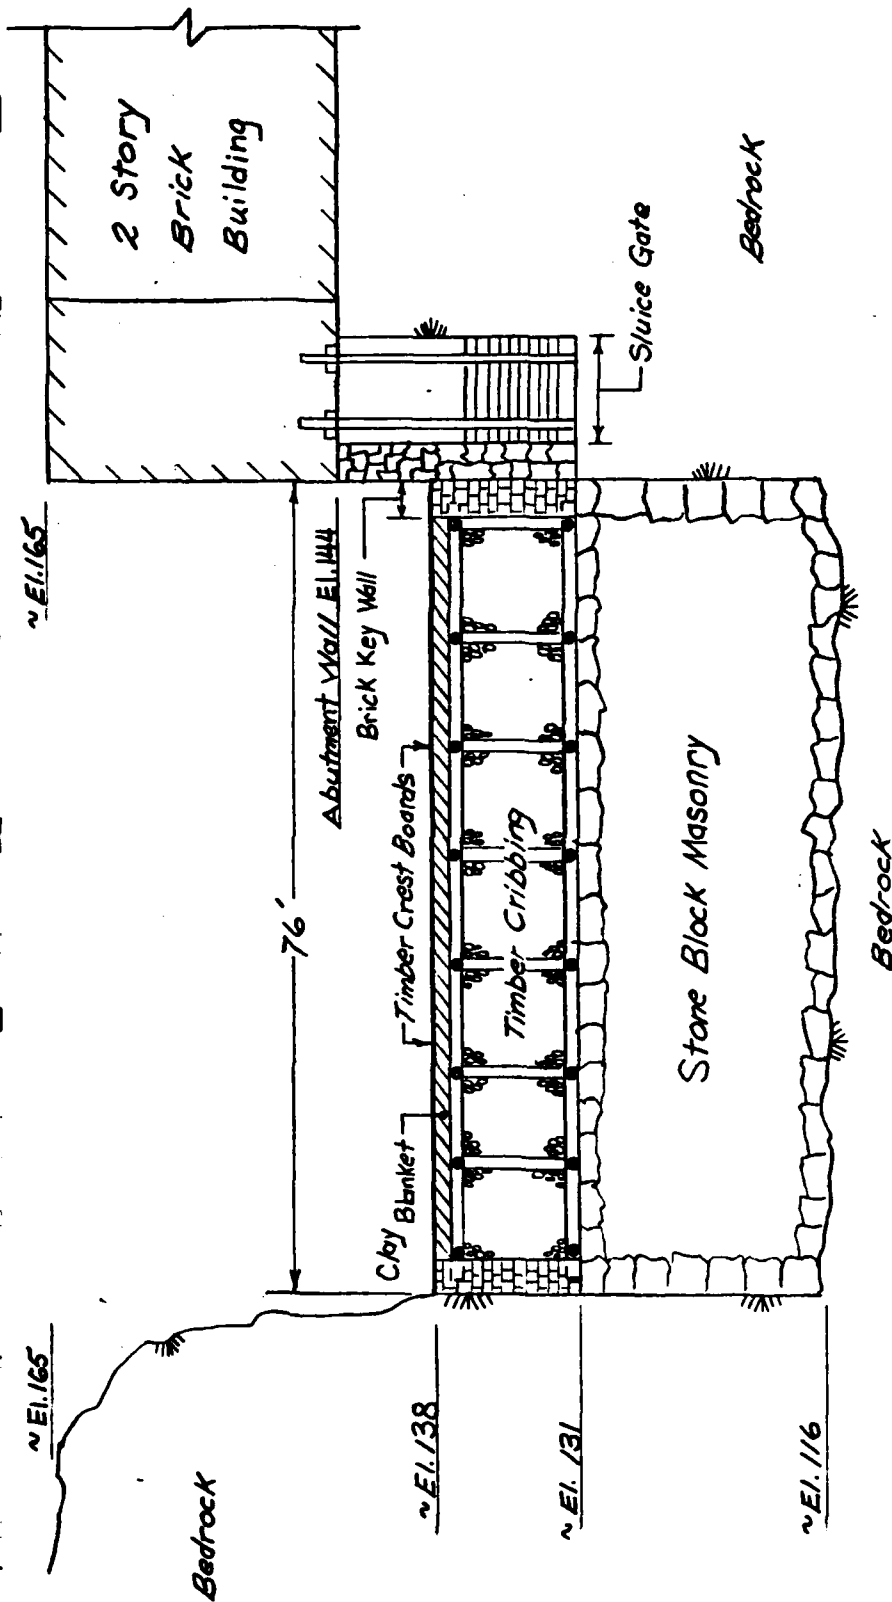
# UPSTREAM PROFILE SCITICO DAM

*Note: Sketch prepared from visual inspection and recorded observations made during remedial repairs in 1955.*
